New Breed of Hickeys in Offset Lithography

Part II: Metal Contamination

M.F. Gratton*

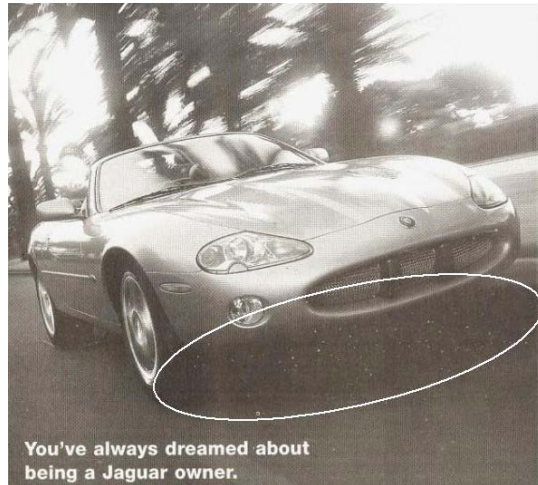
Print defects can take one of several forms and an exhaustive list here would serve little or no purpose. However, in the case at hand, misprints in the shape of “white spots” were observed in a newspaper pressroom and the first characterization was that of hickeys principally in the black solids (Figure 1).

Figure 1: Print defects called “white spots” (after 43,000 copies).

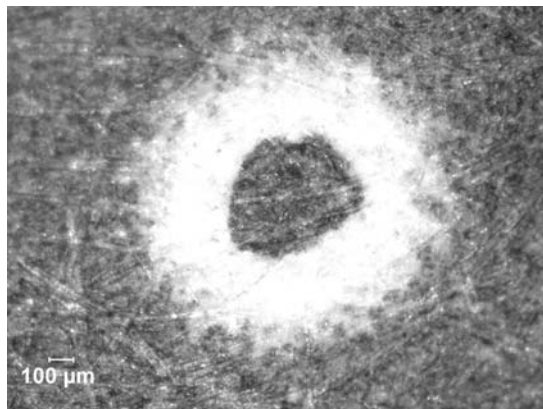
Figure 2: Classic doughnut hickey.

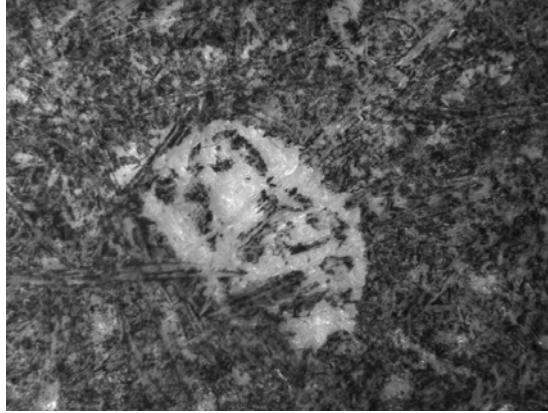
Contamination from paper normally produces void hickies; but now in Part I of this study [1], we have identified a new type of hickey with a particular shape, generated by plastic particles adhering to the blanket. The resulting print defect is a “white spot” on a macroscopic scale, but we found that the print defect is formed in a manner similar to that of a conventional hickey with the exception that the contaminating particle transfers ink only partially, thus leading to the characteristic shape illustrated in Figure 3.

Figure 3: Print defect on solid black image caused by plastic particle stuck on blanket [1].

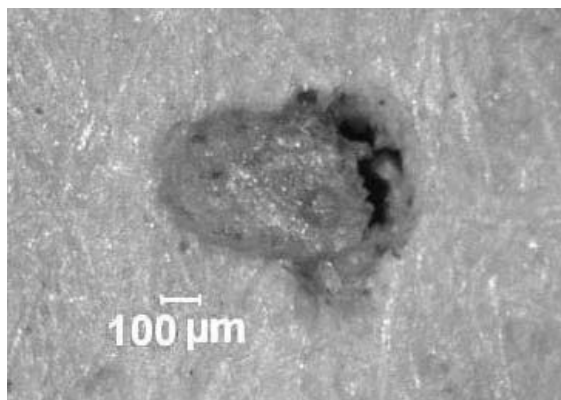
Figure 4: Sclereid cell picked out of the paper [1].

This paper contained sclereid cells, a phenomenon more prevalent in winter (the print defects were first reported in January), and their shape and size could easily be mistaken for plastic particles as seen in Part I of the study [1]). Their sizes were also compatible with the size of the print defects. However, sclereid cells had never caused any significant amount of print defects before, probably because they are not removed from the paper surface during printing and if so, they will adhere only to the blanket, transfer ink while on the blanket but not stick permanently onto it. Another possible mechanism for sclereid cells to cause similar print defects would be to be picked out of the sheet after the ink had been laid down thus leaving an unprinted spot behind; however, we inspected numerous “white spots” under a microscope and never found a hole in

the sheet that could house the sclereids as seen in Figure 4, hence there was never any evidence to support this mechanism. Furthermore, the number of sclereids in a sheet of paper in no way matched the high concentration of “white spots” encountered on the prints. Finally, this pressroom was the only one to experience such defects with this particular paper and nowhere else had such a problem been reported.

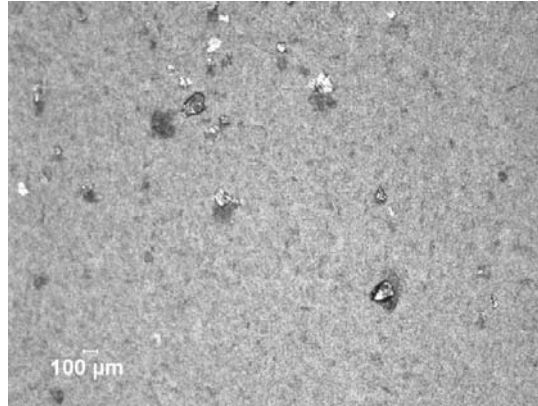
Concomitantly, we carried a preliminary microscopy study on the tape pulls as well as on various other samples available: printed and unprinted paper and a printing plate. No blankets had been supplied as they were being utilized on other jobs without problems and therefore had not been considered as a potential cause. In this study, we discovered the presence of metal-like particles clinging to the plates in the image areas where the defects had been most prevalent. Alongside or close to those particles, we could observe dark spots or stains as well (Figure 5).

Figure 5: Metal particles and dark areas (stains) found on printing plate yielding “white spots”.

Several sections of plates that had produced contaminated images were investigated and apart from the high concentration of iron particles and dark stains as shown in Figure 5, we found the odd scratch or defect in the polymer that we were able to identify on the images (Figures 6-7). It is however worth mentioning that some areas showed rather large “dirty” areas (Figure 11) but we could not determine if they contributed more, or different defects.

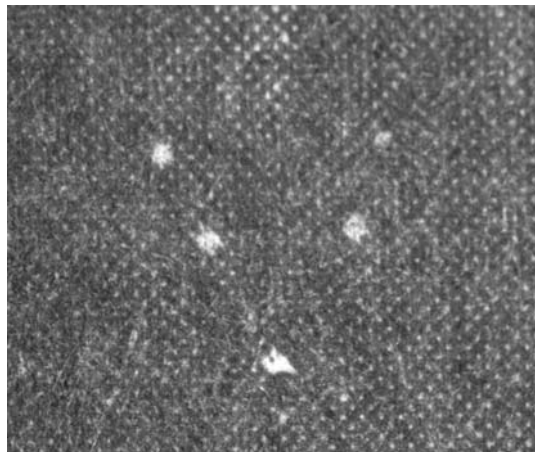
Figure 6: “White spots” on a heavy screened image.

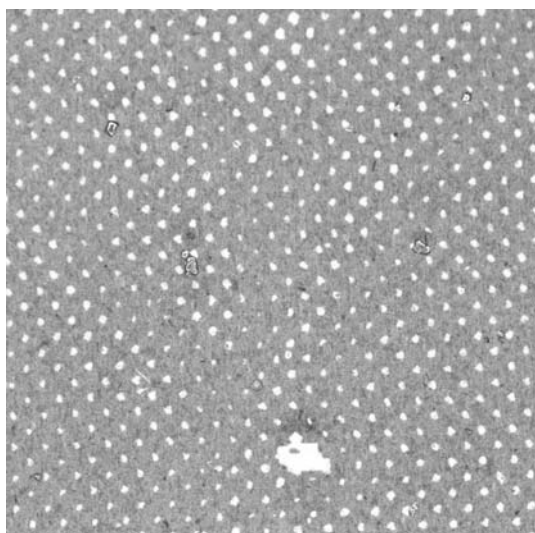
Figure 7: Metal particles stuck onto the plate that match the “white spots” in Figure 6.

The white defect in the lower section of Figure 7 is damage to the polymer of the plate.

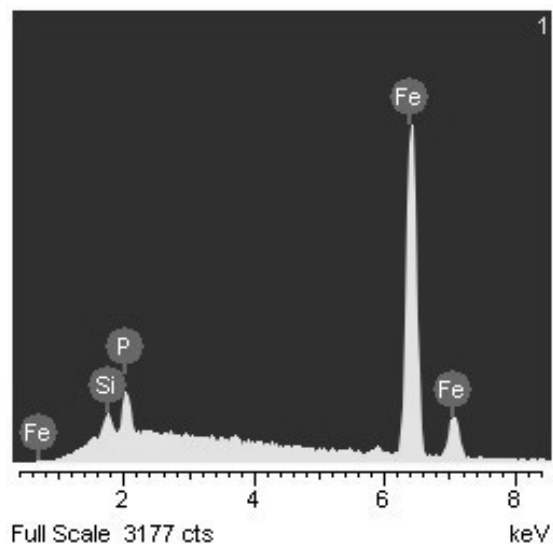
Figure 8: EDS spectrum of metal particles stuck onto the plate in Figure 7. The dominant element is iron.

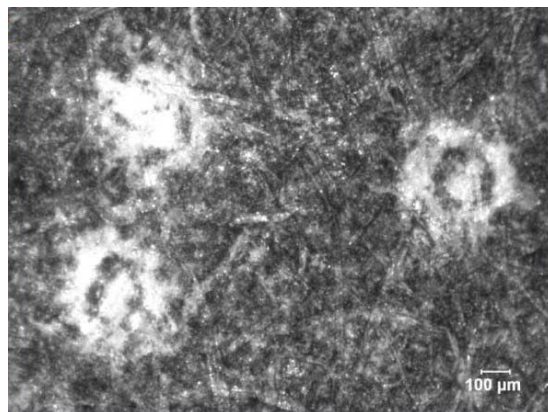
The peculiar pattern is shown in Figure 9 whereby a ring more or less regular is printed within the unprinted “void” of the hickey, in as much as the word “hickey” is used to describe a print defect rather than a contaminant. A significant fraction of all “white spots” on the contaminated images exhibited this “ring” characteristic. We singled out several such hickeys in both solid images and halftone screens, and this author believes that they too constituted a new breed of hickeys that will be referred to as “ring hickeys” in the rest of this report.

Figure 9: Cluster of ring hickeys on a solid black image.

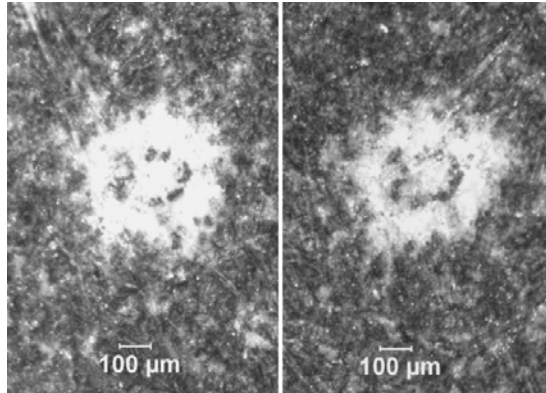
It was possible to demonstrate the stability of ring hickeys as shown in Figure 10 where the pattern was distinct after 5,000 copies and then still evident after 70,000 copies. It was even possible to match the defect with the particle responsible (Figure 11).

Figure 10: Ring hickey after 5,000 copies (left) – same hickey after 70,000 copies (right).

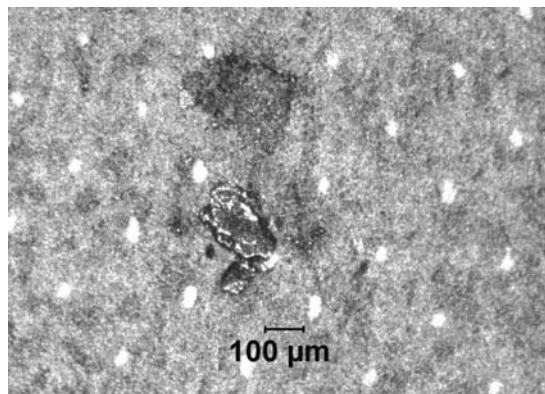
Figure 11: Displaced iron particle responsible for the ring hickey in Figure 10. Notice the dark stain left behind (top).

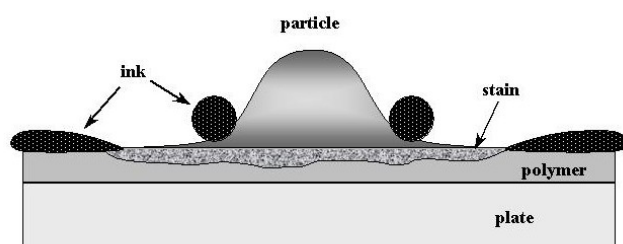
A potential explanation for the formation of such a ring pattern is illustrated in Figure 12. After inking of the plate, the ink will flow down the sides of the iron particle and through a mechanism akin to surface tension, the ink film will split: part will adhere at the bottom and the rest will flow outside of the stain area. The shape of the ring will be as irregular as the shape of the particles as seen in Figure 13 where the left image shows two rings from two particles close to one another and the right image shows a most irregular figure.

Figure 12: Model for “ring hickey” formation: ink flows down and surface tension keeps it around the contour at the bottom of the particle.

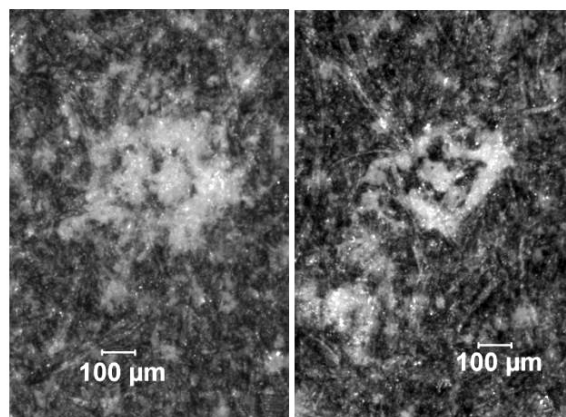
Figure 13: Ring hickeys with irregular shapes.

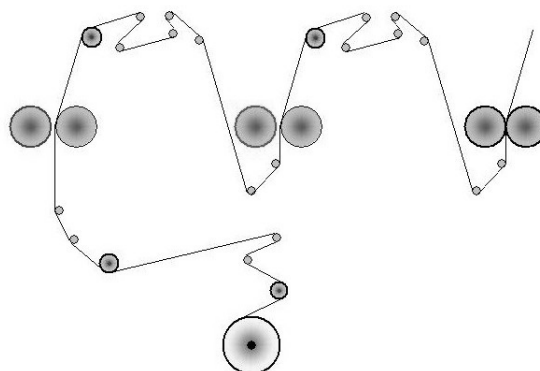
traveled through a festoon with its small diameter rollers that would enhance the dislodging of incrustated particles within the sheet. To test this hypothesis or at least reproduce the conditions in the pressroom, the mill commissioned a local pressroom to run the presumed troubled paper through a similar path (Figure 14) prior to printing large solid black images on both sides of the sheet. It is here that the ring hickey concept proved most valuable: several rolls were printed and the technical staff at the mill who is highly skilled at identifying print defects could neither distinguish similarly high concentrations of “white spots” nor ascertain the presence of ring hickies. This provided us with more evidence that the particles had not originated from the paper.

Figure 14: Web run at commercial printer to simulate the numerous small rollers prior to printing black.

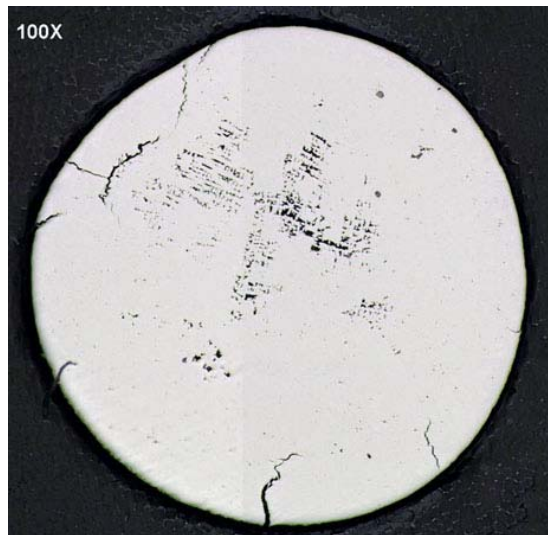
During preparation of the pellets for microprobe analysis, it was shown that they were of poor metallurgical quality. Examination of cross-sections revealed numerous pores and cracks, and small pieces already partially broken as shown in the composite image of Figure 15. This would significantly reduce the resistance of such pellets to impact.

Figure 15: Cross-section of a steel pellet used to grind ink (diameter ~2mm).

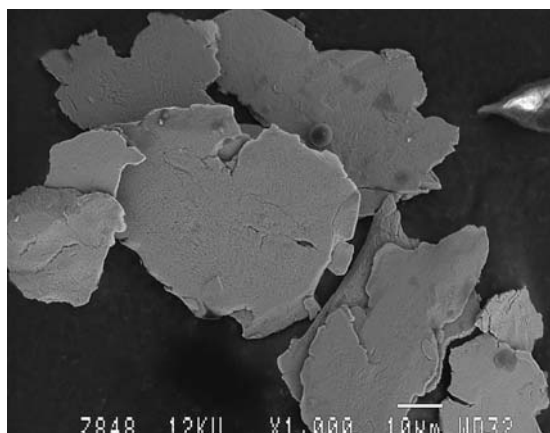
At the end of the run we collected the plates and found them covered with a fine dust. We made similar observations on plates set aside that had been used the night before but to a much lesser extent, as the coverage was only a fraction of that on the test plates. The dust had been observed by press crews before. The next day, a brief analysis in Scanning Electron Microscopy revealed that the dust particles were pure iron (Figures 16 and 17).

Figure 16: SEM micrograph of dust particles on plate.

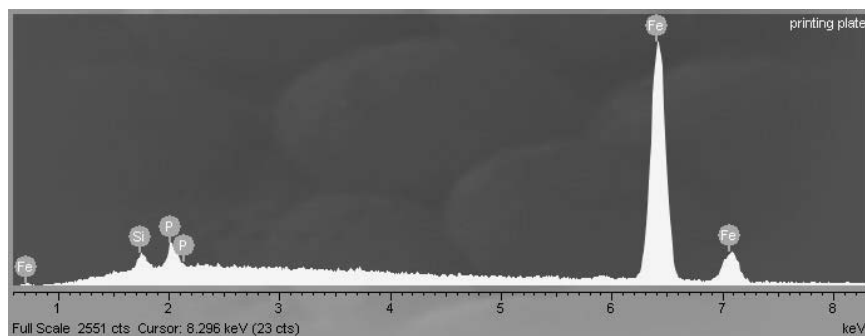
Figure 17: EDS spectrum of dust particles showing the strong iron peak.
