Manual and analytical assessment of piling

Dr. Mark Bohan, Eric Cathie and Lindsay Ferrari

PIA/GATF

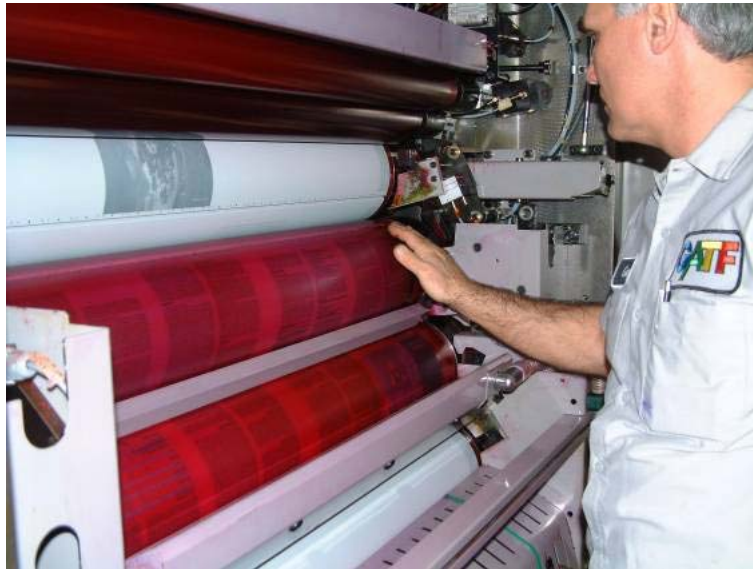
Figure 3: Manual assessment carried out on press

The human evaluation of the piling was made by the same operator and each of these was referred back to a roughness reference gauge before these evaluations were recorded. The use of the roughness gauge ensured that there was consistency over time with the assessments made by the operator. This was confirmed by the repeat trials that were carried out as part of the experimental program. The operator assessed the piling across the whole of the width of the blanket and also around its circumference. This was achieved by feeling the

surface texture and providing a feedback regarding the severity, an example of the assessment is shown in Figure 3. This technique allows the assessment across the whole of the blanket surface and it is not specific to a particular area.

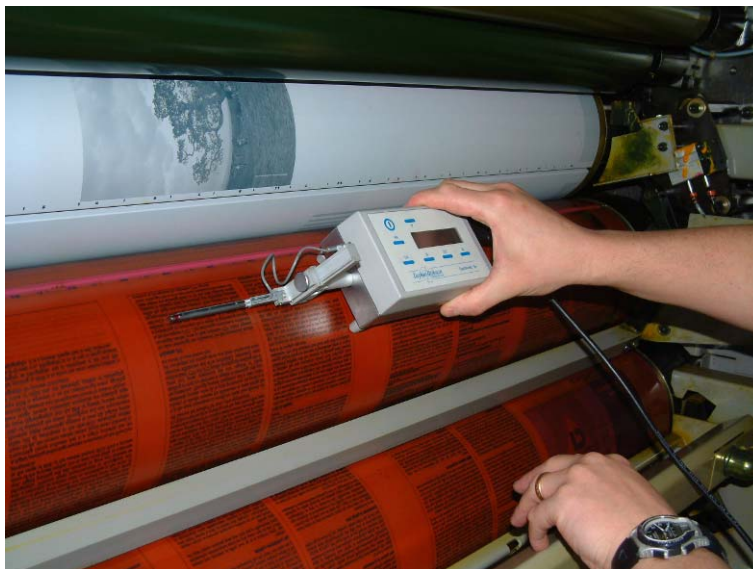
Figure 4: Profilometry carried out on press

The profilometry measurements were taken from the areas highlighted in Figure 2. This allowed the build up of material to be quantified numerically. Two measurement areas are discussed in the paper, those being in a light tonal header region and also in a color target at the transition between two tonal patches. These measurements were carried out for each of the screening areas on top of the unit, while for the bottom blanket of each unit measurements were made in the header region only for each screening. For each of the areas assessed two repeat measurements were made adjacent to each other. Any errors in measurements were immediately apparent in the trace obtained and in these cases further supplemental measurements were taken. These errors were normally due to movement of the profilometer while taking the measurement, positioning of the instrument not parallel to the blanket cylinder or a dirty probe tip. A typical measurement being carried out is shown in Figure 4.

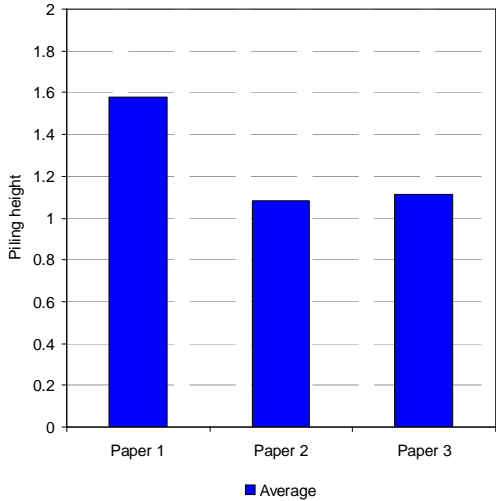
Figure 9: Manually assessed piling levels for paper for the yellow unit

The piling increased throughout the press and the largest piling levels were detected on the yellow units by both the profilometry and manual assessment of the piling. The impact of paper on the level of piling on the yellow unit is shown in Figure 9. The results are different from those obtained from the profilometry, for which the same trends that were evident on the black unit also occurred on the yellow unit, though to a much larger level and with an increasing amount of interactions. The piling on paper one was much larger than either of the other two papers. Papers two and three were a combination of the non image and low coverage piling, identified in the earlier publication. These resulted in an equal effect across the different areas on the blanket. The piling identified with paper one was much higher as there was the occurrence of “worms” on the edge of the paper, Figure 6. These “worms” were the build up of material on the edge of the print area and they would migrate around the circumference of the blanket. They were not detected with any of the profilometry measurements as they were outside the investigation area. The build up of material defined as “worms” were removed after selected trials and samples analyzed for their composition using EDS and FTIR analysis. The analysis of the samples indicated that these were a build-up of the paper coating and ink. In certain cases, there was also an indication that there was some of the base sheet included in the samples. The “worms” occurred to a greater extent with paper one and this resulted in the higher piling rating. The “worm” thickness was relatively large and could give rise to a smash of the blanket surface. In most cases the blankets were changed prior to cleaning. If the build-up was low, following cleaning of the blanket the surface was also checked and if there was any sign of a smash in the blanket it

was changed. This result shows the importance of using multiple assessment techniques when assessing piling. The profilometry allows the detailed investigation of specific areas and types of piling that is occurring while the manual assessment allows global effects to be characterized and monitored.
