New Breed of Hickeys in Offset Lithography

Part II: Metal Contamination

M.F. Gratton*

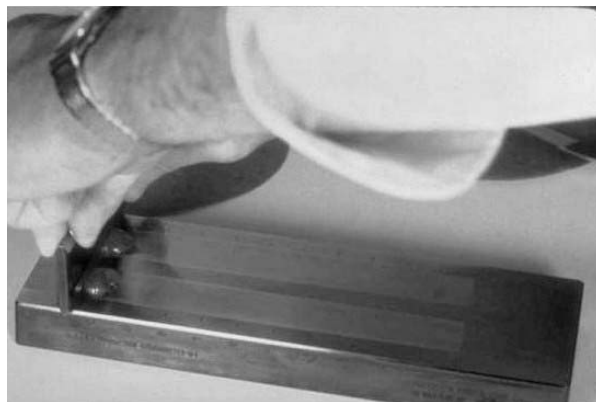
Figure A1: NPIRI grindometer to perform grind test for ink.

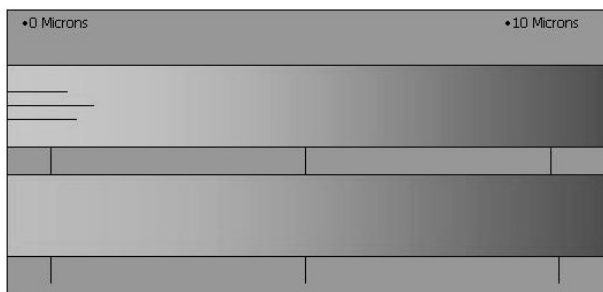
In the example here, the specification of 4/1 means that the size of the larger particles would be $10\ \mu\text{m}$ (4×2.5) and the streaks would disappear at $2.5\ \mu\text{m}$ (1×2.5).

Figure A2: Details of the graduation on the NPIRI grindometer.
